Manhole Inspection Summary

Manhole # S41E__070MH

Insp Date: **5/27/09 12:16 PM**

Location Address: **AISQUITH ST**

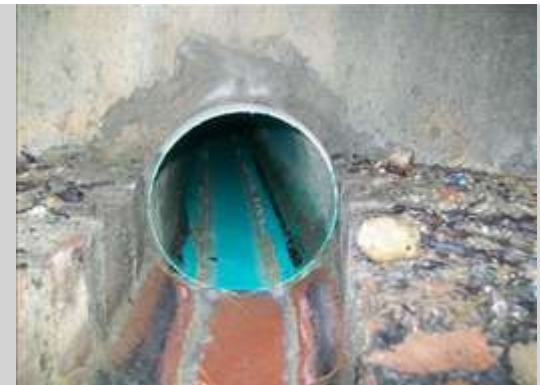
3 O'Clock Inflow

8 in. Circular Gravity Sewer
Pipe In @ 3 O'Clock

Pipe Height: **8.4** (in.) Rod and Bar (Angled)
Pipe Material: **PVC** ☐ Pipe Lined
Invert Depth: **10.17** (ft.) Flow Characteristics: **Slow**
Deposits: ☒ **None** ☐ Mud ☐ Sludge ☐ Debris ☐ Grease
Silt Depth: **0** (in.) Deposits Extent:
Infiltration: **None** Pipe Seal Cond: **Sound**
